March 14, 2017

Our Reference: File SV30831, Project 4787755206

Subject: Verification Testing for Fire and Smoke Dampers After
Exposure to Aeroseal "Duct Seal" Spray

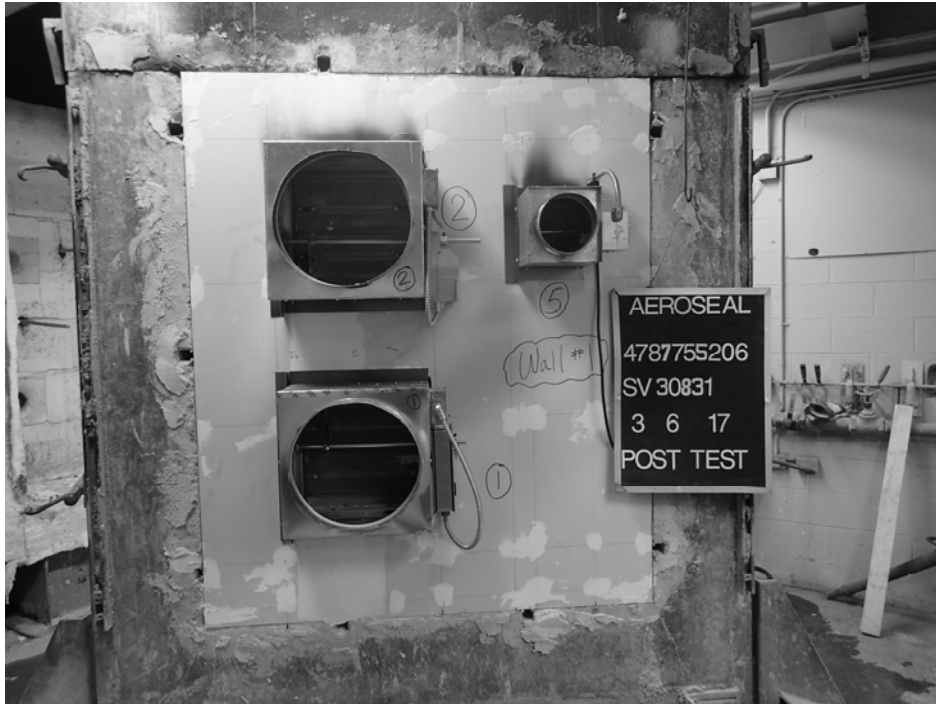
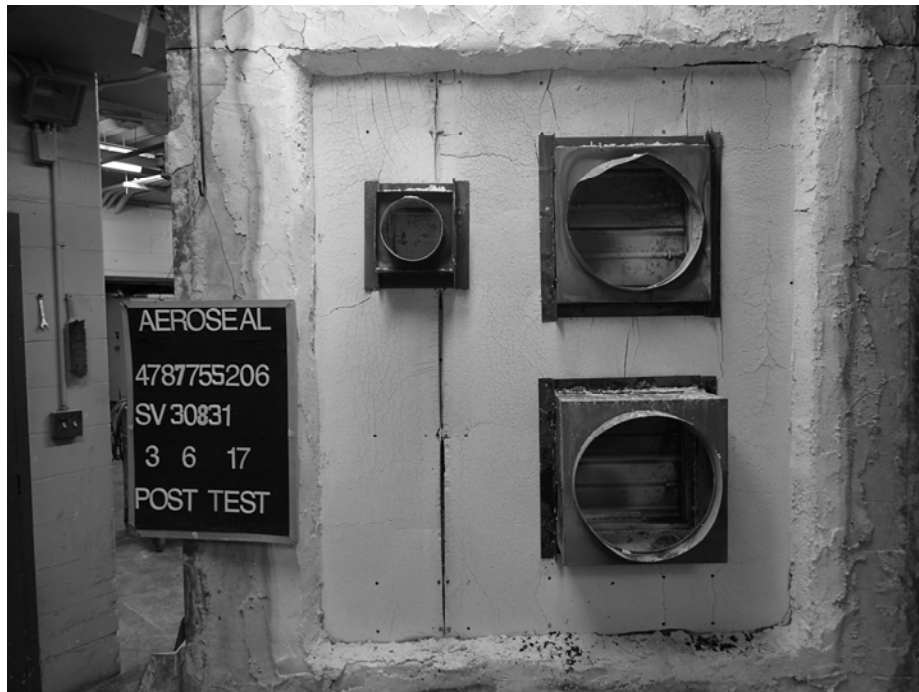
WALL ASSEMBLY NO. 1 / TEST NO. 1

9.5 min	Galv coating of blades in damper #1 is melting.
12 min	Sealant/substance on surface of one blade in damper #1 is melting and flowing down on blade surface (sealant from label which had fallen off the blade?). No flaming on unexposed side of dampers.
23 min	Damper #5 is still emitting smoke from unexposed face but there is no flaming on unexposed surfaces of the 3 dampers. The Aero seal spray in the heavier application areas is drying and discoloring white and on the inside of sleeve, has a snowflake appearance. No flaming on unexposed sides.
45 min	Blades in damper #2 are discoloring and becoming a greenish/orange.
60 min	Blades in damper #2 are red hot. Blades in damper #s 1 and 5 are dark gray in color.
75 min	Gypsum board above dampers 2 and 5 is discoloring black. No flaming on unexposed side of damper assemblies/wall assembly.
90 min	Gas off. The influence of the Aero seal on the dampers had ceased by approx 45 min but at client request we continued the test for 90 min.

Observations After Fire Exposure Test (Wall Assembly No. 1) - The dampers closed and latched as intended and in accordance with the applicable requirements of the Standard during the fire exposure and no flaming was observed on the nonfire side of the dampers.

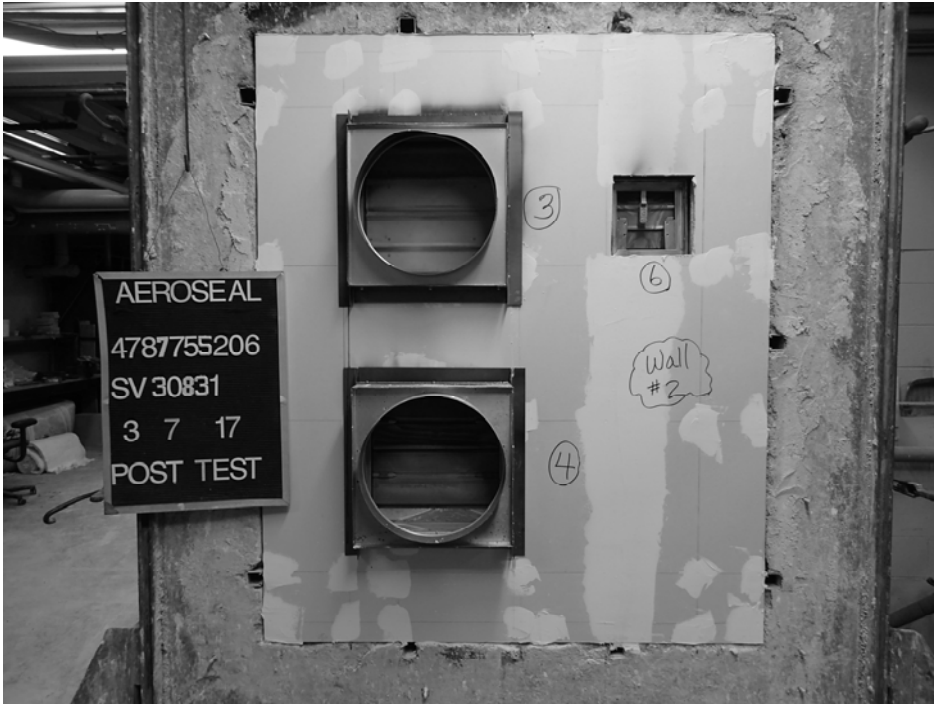
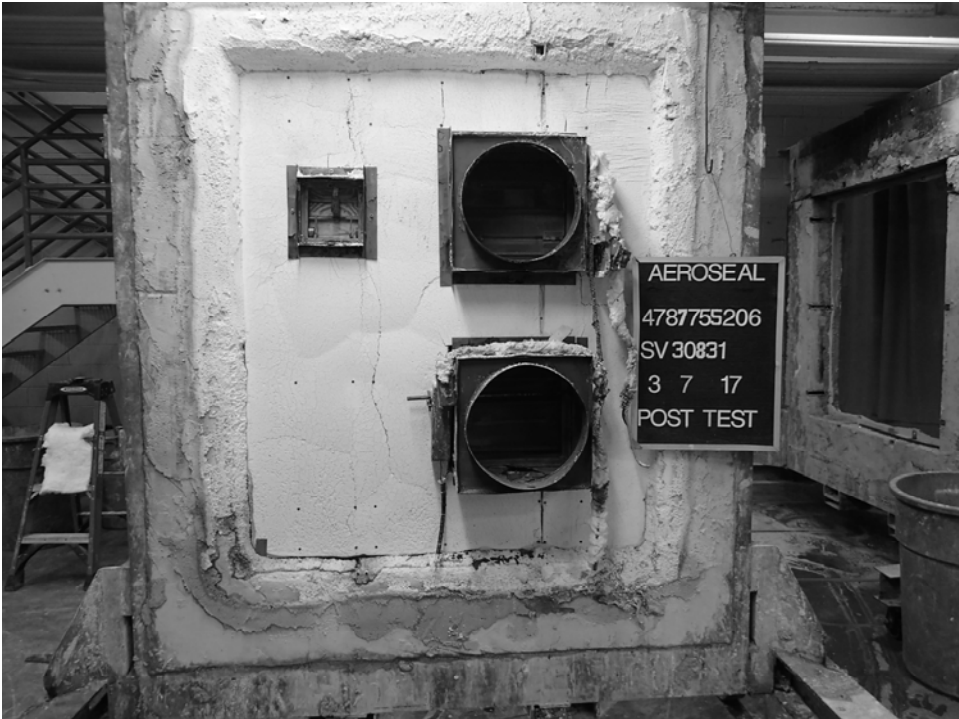
WALL ASSEMBLY NO. 2 / TEST NO. 2

7 min	Damper #3 blades are discolored black.
10 min	Flames of wires and motors on fire side of assembly still evident. No flaming on unexposed side of assembly.
12 min	Fire side flames nearly ceased. On nonfire side, bottom blade in damper #4 is discolored black.
23 min	Black discoloring of blades on nonfire side has now disappeared and blades are dull gray. No flaming unexposed side.
40 min	No flaming on unexposed side of test assembly. Damper blades in #3 are slight green tint in color. Gypsum bd above dampers 3 and 6 is discoloring brown a small amount.
60 min	Damper blades in sample 3 are all discolored green. No flaming unexposed side of test assembly.
75 min	Damper blades in samples 3 and 4 glowing red. Discoloring of gypsum board above openings 3 and 6 continues. Blades in curtain damper are discoloring gray.
90 min	Gas off

Observations After Fire Exposure Test (Wall Assembly No. 2) - The multiblade dampers closed and latched as intended and in accordance with the applicable requirements of the Standard during the fire exposure and no flaming was observed on the nonfire side of the dampers. Although the curtain damper did not fully close when the fusible link melted, this was not attributed to the Aeroseal spray. It was observed that the damper was skewed within the wall opening resulting in a reduced blade to frame operating clearance at one side which inhibited full closure. Once the blades were manually pushed to full close, the curtain damper performed in accordance with the applicable requirements of the Standard during the fire exposure and no flaming was observed on the nonfire side of the damper.
