Field Investigation of Duct System Performance in California Light Commercial Buildings (Round II)

Wm. Woody Delp, Nance E. Matson, Darryl J. Dickerhoff, and Mark P. Modera, Lawrence Berkeley National Laboratory, Berkeley, CA

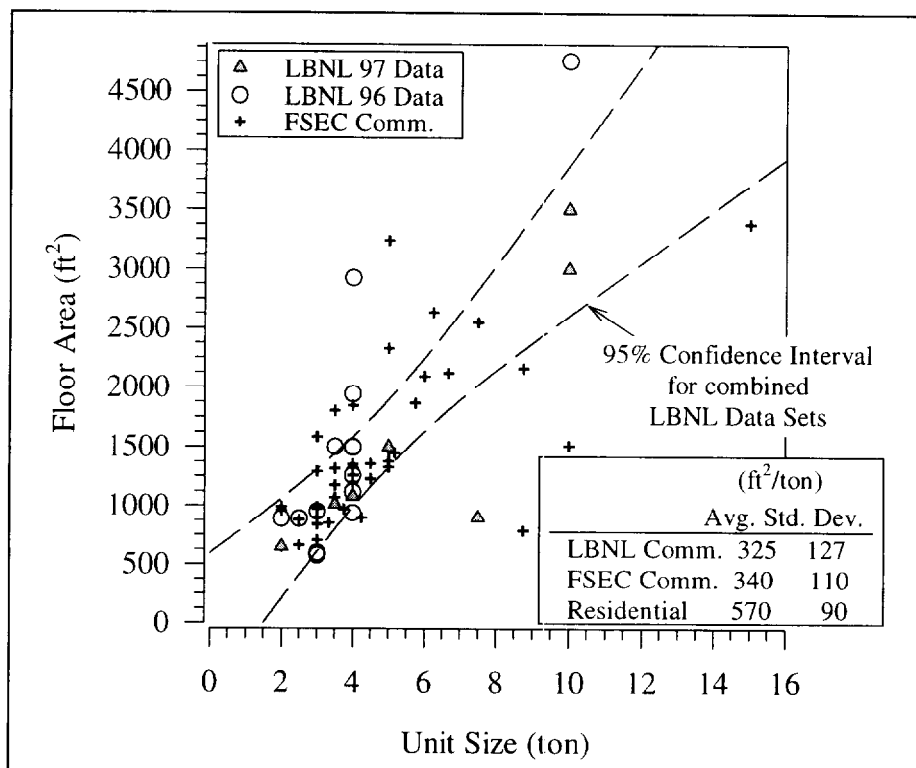
Figure 1. Floor area -vs- unit size: using the 1996 and 1997 LBNL and FSEC (Cummings, et al., 1996) commercial data along with residential (Jump, et al., 1996) summary information. The FSEC unit size is derived from the total installed capacity in the building divided by the number of units.

Figure 1 shows the floor area versus the unit size, for both the LBNL and the FSEC data sets. The important point here is the floor area served by each unit. This figure shows that the California (LBNL) buildings are similar to those in Florida (FSEC). Light-commercial buildings frequently have a greater load density (ton/ft^2) than single-family residential homes, due to internal loads such as equipment, lights, and people. Unfortunately with many light-commercial buildings accurate load information is not available during design, and contractors/engineers resort to a rule-of-thumb approach to equipment selection, often resulting in oversized equipment. (Less than half of the systems tested had any plans.) It is worth noting the values in the figures are installed capacities, and do not necessarily correspond to actual space loads.

The twenty-five systems had an average unit size of 4.9 tons, this compares with the FSEC data of 4.5 tons, and the residential of 2.9 tons (Jump, et al., 1996).

The average floor area served by each unit was 1,575 ft² for the current study, 1,400 ft² for the FSEC buildings, and 1,800 ft² for the residential buildings. Since the area served by each commercial unit is smaller than residential, and the units have a greater capacity, commercial buildings have larger units on a floor area basis than residential buildings. The commercial buildings averaged between 325 and 340 ft²/ton while the California residential buildings averaged 570 ft²/ton. Assuming duct loss mechanisms scale with capacity, this indicates light-commercial buildings potentially have greater duct losses on a building floor area basis than residential buildings.

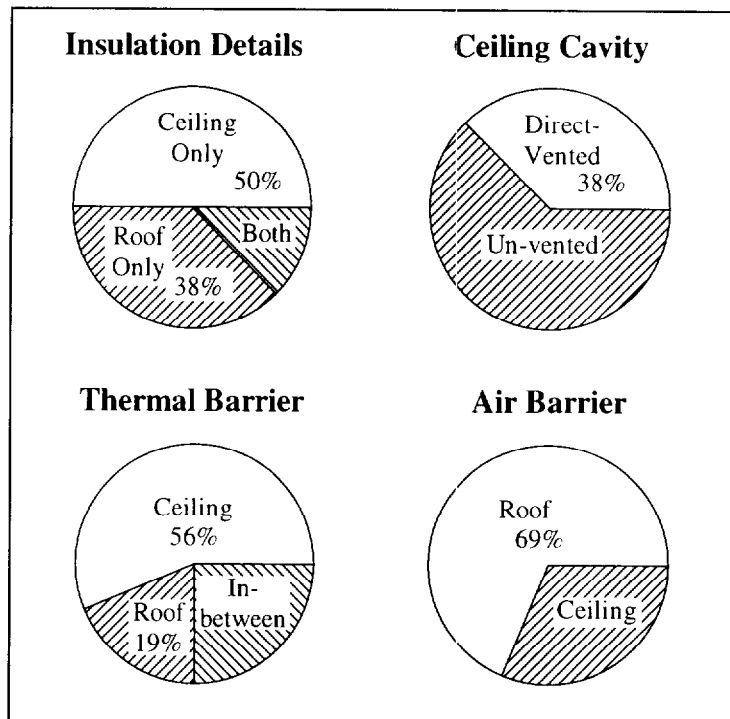
Figure 2. Building thermal and air barrier characterization for the 1996 and 1997 LBNL commercial buildings.

In order to understand the dynamics of duct losses, details of the building need to be determined. Figure 2 summarizes many of the characterization details pertaining to the buildings. All the buildings had a drop ceiling with the duct runs in the ceiling cavity. Because of this, two critical building details are the location of the thermal and the air barrier. Fifty percent of the buildings had insulation placed at the roof deck, 38% on the ceiling tiles, and the remainder had insulation at both locations. Thirty eight percent of the buildings had a directly vented ceiling cavity. In these buildings, the lay-in acoustical ceiling tiles formed the major air barrier. In 56% of the buildings the primary thermal barrier was at the ceiling tiles, which implies that the ducts are entirely outside the conditioned space. In 25% of the buildings the ceiling cavity acted like a buffer zone, with the temperature floating between the room and outside temperatures. With these buildings, the thermal barrier is in-between the roof and ceiling. In the remainder of the buildings the thermal barrier was at the roof, however even in these buildings, the ceiling cavity temperature was slightly higher than the room.

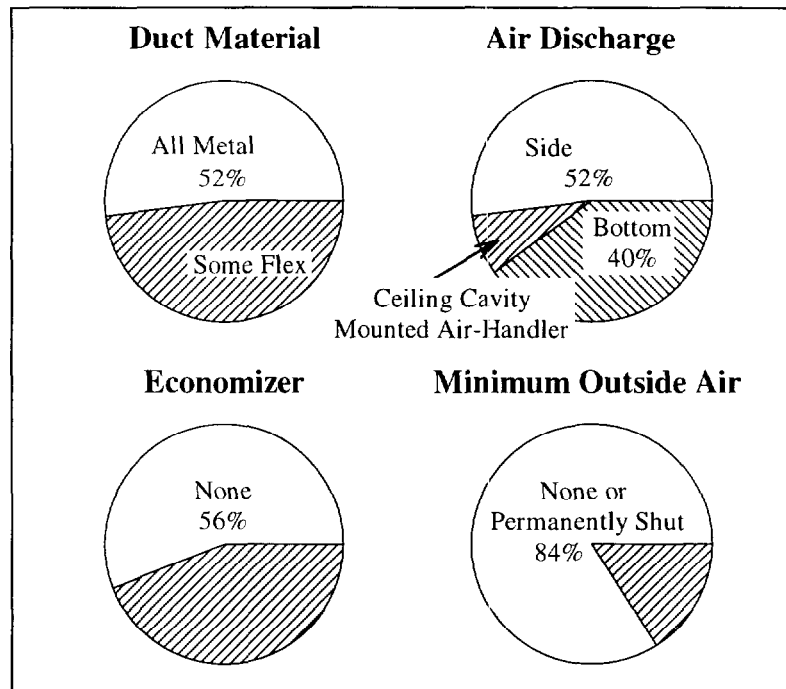
Figure 3. Characterization of HVAC unit details for the 1996 and 1997 LBNL commercial buildings.

Figure 3 summarizes HVAC unit characterization details. Duct material fell into two basic types (both with some insulation): all metal trunk-and-branch, and flex-octopus (flexible duct with individual ducts running in as straight as line as possible to the register from the plenum). 52% of the systems had all metal ducts, while the remainder had some form of flex-octopus. There are two types of basic ductwork configurations found with the typical light-commercial package roof-top unit: bottom discharge, and side discharge. Bottom-discharge eliminates ductwork exposed outside since it penetrates the roof directly under the unit. The typical side-discharge installation includes 90° elbows directly off the unit, ideally cutting down on the amount of duct exposed on the roof. Economics and local practice govern which method is used. Bottom discharge units require the use of a special curb to support the unit, while side discharge units typically use a field-fabricated platform for the unit. 40% of the HVAC units had bottom-discharge ductwork, while the remainder used a side-discharge arrangement.

Air side economizers minimize cooling energy use when it is cooler outside than inside. Fifty six percent of the units had some sort of economizer; however, they were not checked for functionality. Only 16% of the units had functioning minimum outside air (either an intentional opening in the return duct directly to outside, or a minimum setting on the economizer). All of the others either had no outside air provisions, or had the dampers permanently shut.

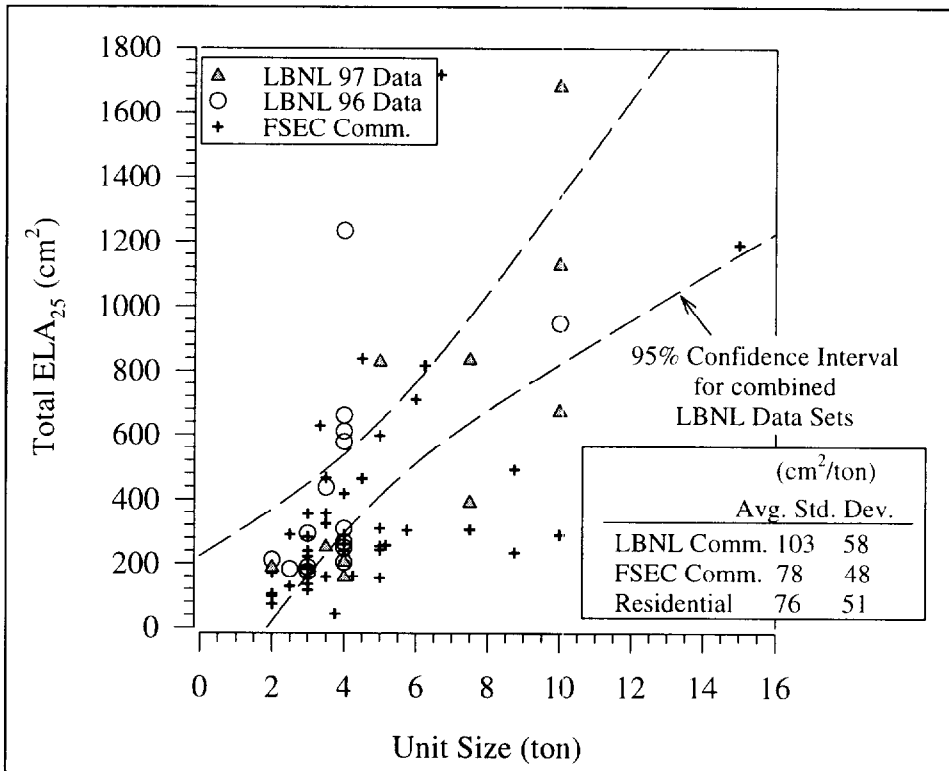
Figure 4. Combined leakage area (ELA₂₅) -vs- unit size using the 1996 and 1997 LBNL and FSEC (Cummings, et al., 1996) commercial data along with residential (Jump, et al., 1996) summary information. Combined leakage area includes both supply and return leakage. The FSEC unit size is derived from the total installed capacity in the building divided by the number of units.

Figure 4 shows the combined leakage area (ELA_{25}) versus the unit size for both commercial data sets. The data have a large spread in values. The dashed lines in the figure represent the 95% confidence interval for a linear regression on the combined LBNL data sets. This interval is the region where there is a 95% confidence in the predicted value. By observation, the LBNL and the FSEC leakage values fall in the same broad general range for any given unit size. Normalizing leakage area with the unit size (cm^2/ton) does not yield a constant due to the large spread in values. However, the residential and FSEC commercial data sets had similar average values for leakage area per ton (cm^2/ton), while the LBNL (both 96 and 97) commercial buildings had ~30% higher average value, possibly due to a greater spread in the data.

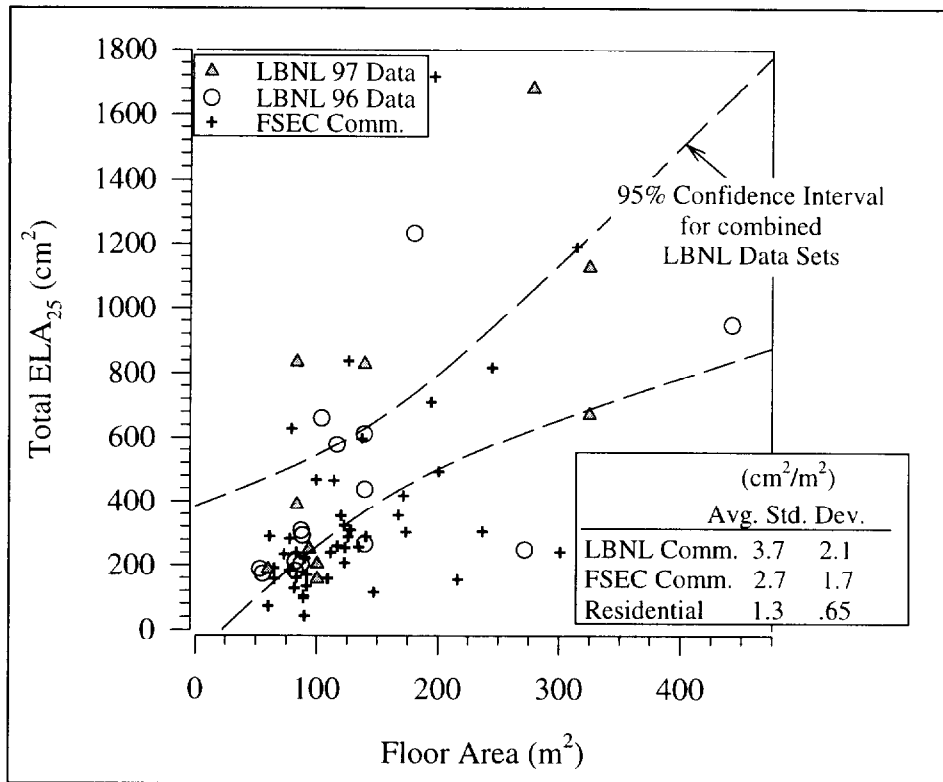
Figure 5. Combined leakage area (ELA₂₅) -vs- floor area using the 1996 and 1997 LBNL and FSEC (Cummings, et al., 1996) commercial data along with residential (Jump, et al., 1996) summary information. Combined leakage area includes both supply and return leakage.

Figure 5 shows the combined leakage area (ELA₂₅) versus the floor area for both commercial data sets. Again, the data show a large spread in values. The dashed lines in the figure represent the 95% confidence interval for a linear regression on the combined LBNL data sets. The LBNL data grouping is similar to, and slightly higher than, the FSEC data. As an order of magnitude estimator on a larger stock of buildings, in residential work, it is common to present building envelope leakage results by normalizing leakage area with floor area (cm²/m²). The average cm²/m² in the LBNL data set was 2.8 times that of the residential data, while the FSEC data was just over 2 times the residential. These data suggest that light-commercial duct systems leak air at a rate much greater than residential systems, for any given floor area.

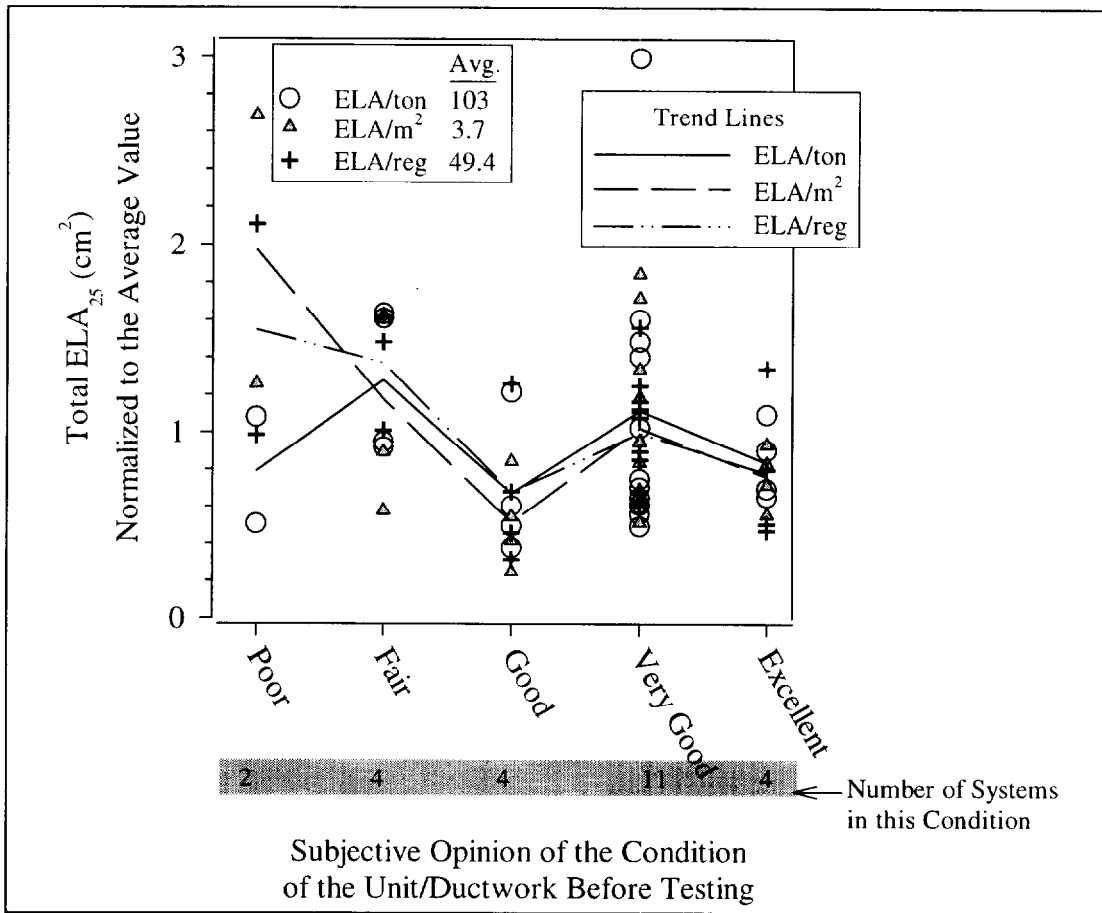
Figure 6. Normalized total effective leakage area (ELA₂₅) vs. a subjective opinion of the condition of the HVAC unit and its duct system, using the 1996 and 1997 LBNL light-commercial data. Total effective leakage area includes both supply and return leakage. The normalized values (ELA/ton, ELA/m², and ELA/reg) are further normalized by dividing by the appropriate average of the normalized values.

Figure 6 has taken the normalized combined ELA₂₅ effective leakage areas (normalized by equipment capacity, floor area, and the number of registers; ELA/ton, ELA/m², and ELA/reg) and further normalized these values by dividing by the average of the initial normalized value. A value of 1 is then the average of the sample. These twice-normalized values are plotted against a subjective opinion of the condition of the equipment/ductwork. This opinion was that of the researchers and was based on visual clues such as damaged ducts, damaged HVAC cabinets, the presence of mastic, and the general appearance above the ceiling cavity. The possible ratings were poor, fair, good, very good, and excellent. Regardless of the normalization value chosen, the figure shows that the researchers did not do a very good job of predicting which systems had a high ELA₂₅.
